**BERTHOUD PASS WEST
SEDIMENT CONTROL ACTION PLAN
US 40 Milepost 232.8 to 244.3**

Colorado Department of Transportation

**Clear Creek Consultants
Felsburg Holt & Ullevig
Yeh & Associates**

May 2017

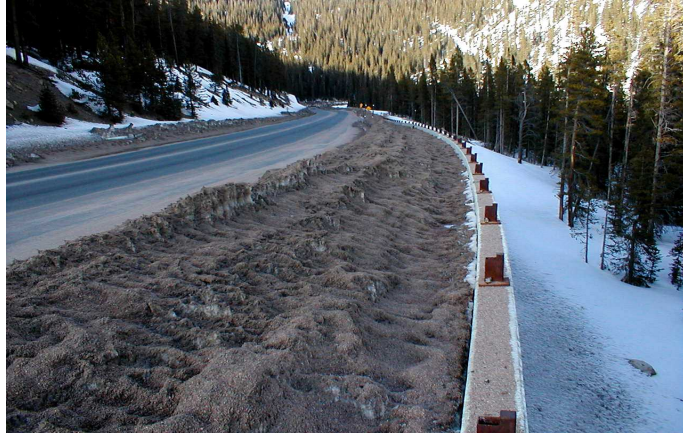
Sediment accumulation in snow storage area on Berthoud Pass East

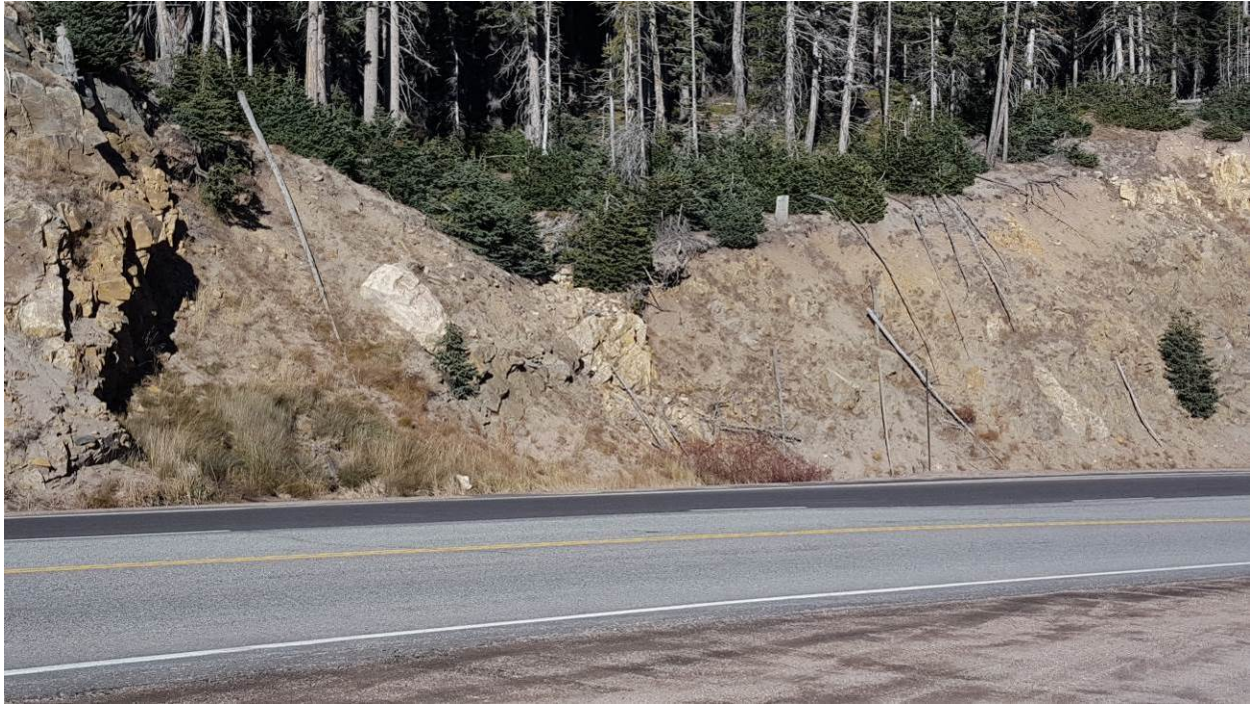
At milepost 242.35 are two sites, A and B, which may be contributing to sedimentation. Site 242.35 A is an existing drainage channel with shallow bedrock overlain by glacial till and alluvium (**Figure 7-1**). Site 242.35 B consists of weathered igneous bedrock that is less resistant than adjacent slopes, which suggests the presence of a fault (**Figure 7-2**). This site has little vegetation and is covered with grus, or coarse grained, angular, sand and gravel sized material resulting from the chemical and mechanical weathering of granitic rocks. No erosion control structures were observed at these two sites at the time of investigation. Site 242.35 A is approximately 300 feet long by 20 feet high. The dimensions of site 242.35 B are approximately 50 feet by 50 feet.

Figure 7-1. Drainage channel at 242.35 A

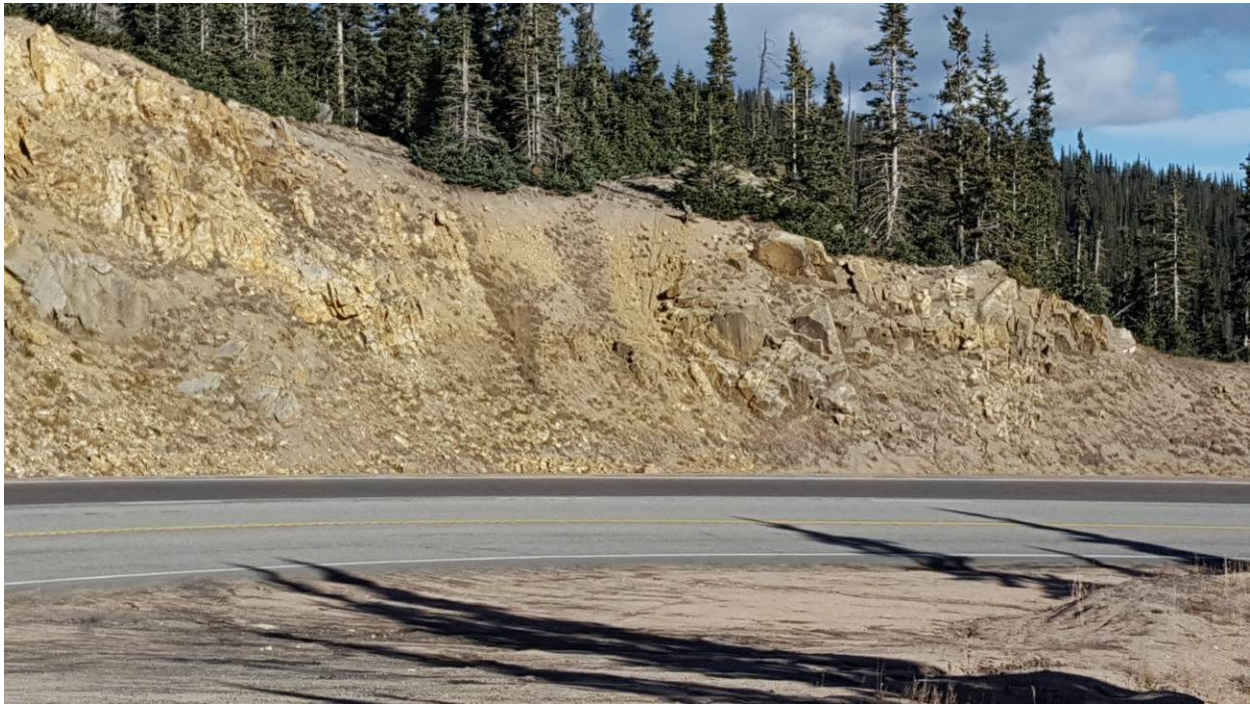
Figure 7-2. Weathered bedrock and possible fault shedding sediment at milepost 242.35 B

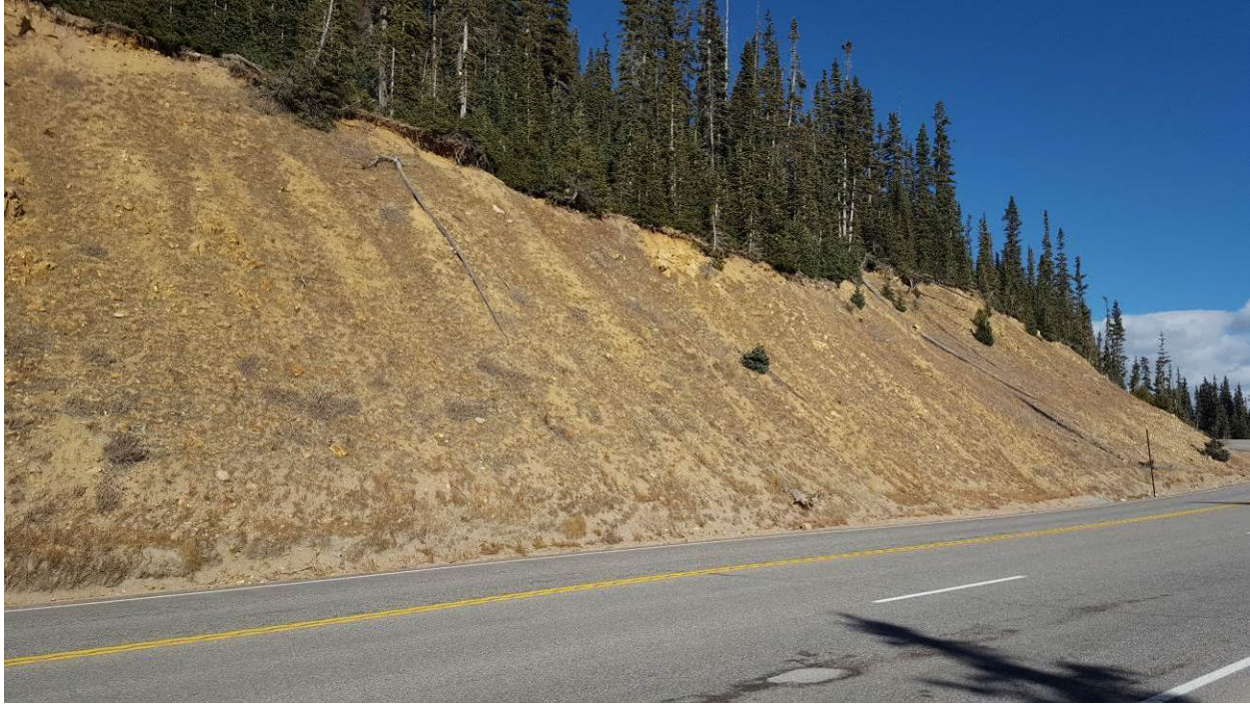
Figure 7-3. Milepost 242.1

At milepost 242.1 the cutslope consists of extremely weathered bedrock (residuum) and alluvium (**Figure 7-3**). Some smaller fir trees and thin grassy vegetation is growing on the slope. There is some minor raveling at the brow and minor undercutting of the base of the slope by seasonal runoff flowing in the shoulder ditch. This site is approximately 450 feet wide by 75 feet high.

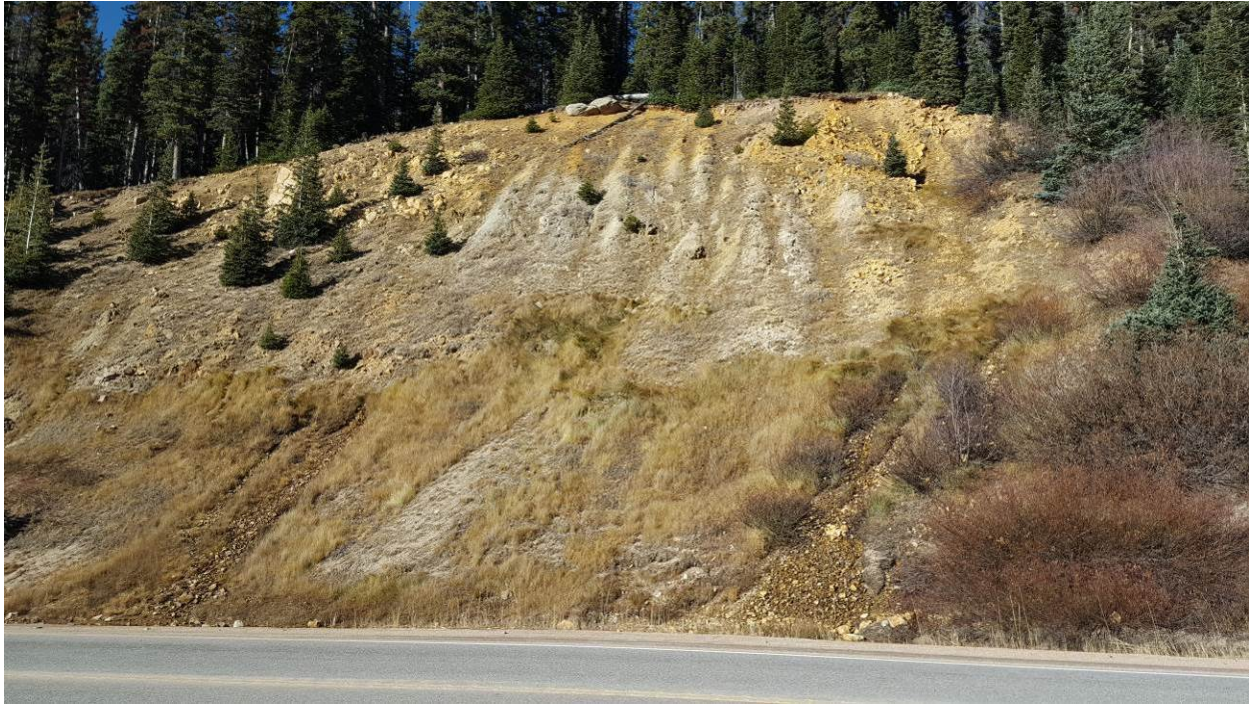
The slope at milepost 241.95 consists of highly weathered bedrock with a pocket of glacial till (**Figure 7-4**). The brow and upper area including both till and bedrock is oversteepened. At the time of investigation, there were active seeps in the lower, bedrock portion of the slope and no erosion control measures were observed. The dimensions of the oversteepened area of this slope are approximately 600 feet width and 30 feet height.

Figure 7-4. Milepost 241.95. The pocket of glacial till (gray) which was deposited in a channel or valley in the igneous bedrock (orange-brown)

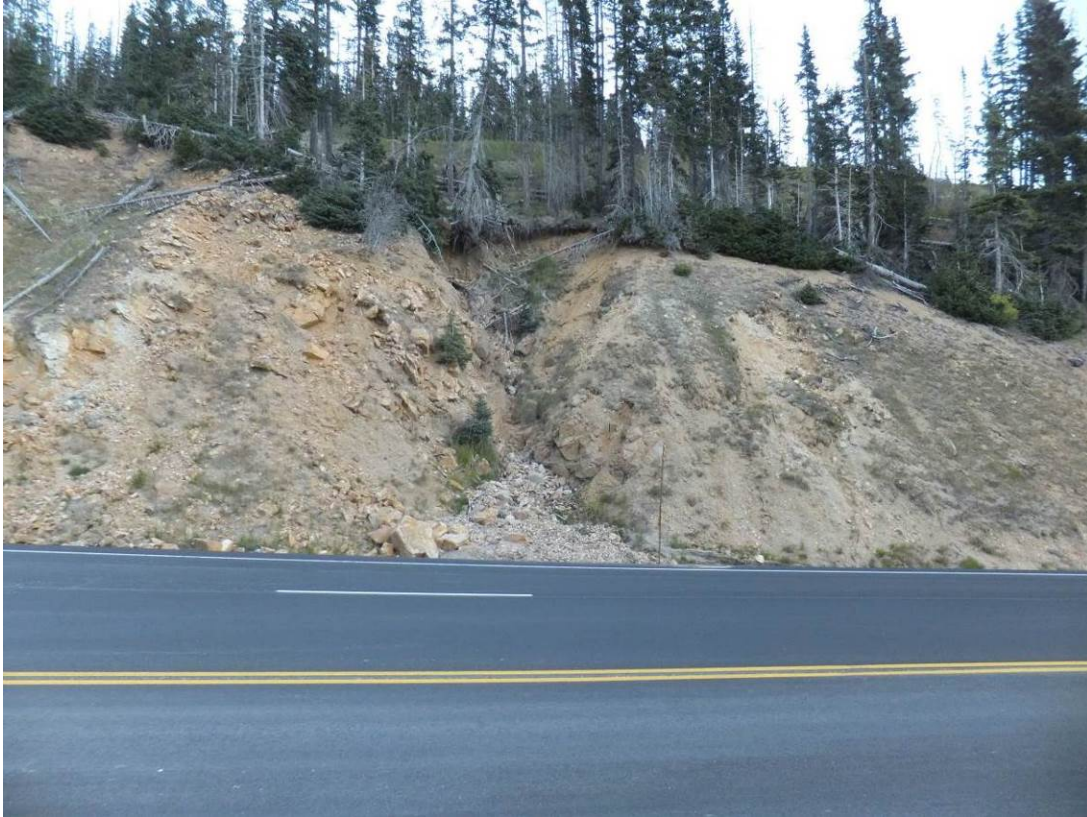
At milepost 241.75, a previously-existing natural drainage channel has apparently weakened and collapsed, causing vegetation and rock at the top of the slope to fall into the drainage (**Figure 7-5**). A corrugated metal culvert outlet pipe opposite the slope across the road and to the east was trickling water at the time of investigation. No culvert inlet was visible at the time of investigation. The collection of rock and sediment at the base of the drainage has apparently buried the inlet. No moving water was observed on the slope at the time of investigation, but the fine sediment resting at the base of the drainage was wet. The site at milepost 241.75 is approximately 330 feet wide by 50 feet high.

Figure 7-5. Slope failure at exiting drainage at milepost 241.75. Culvert inlet is buried by rocks and sediment at base of failure

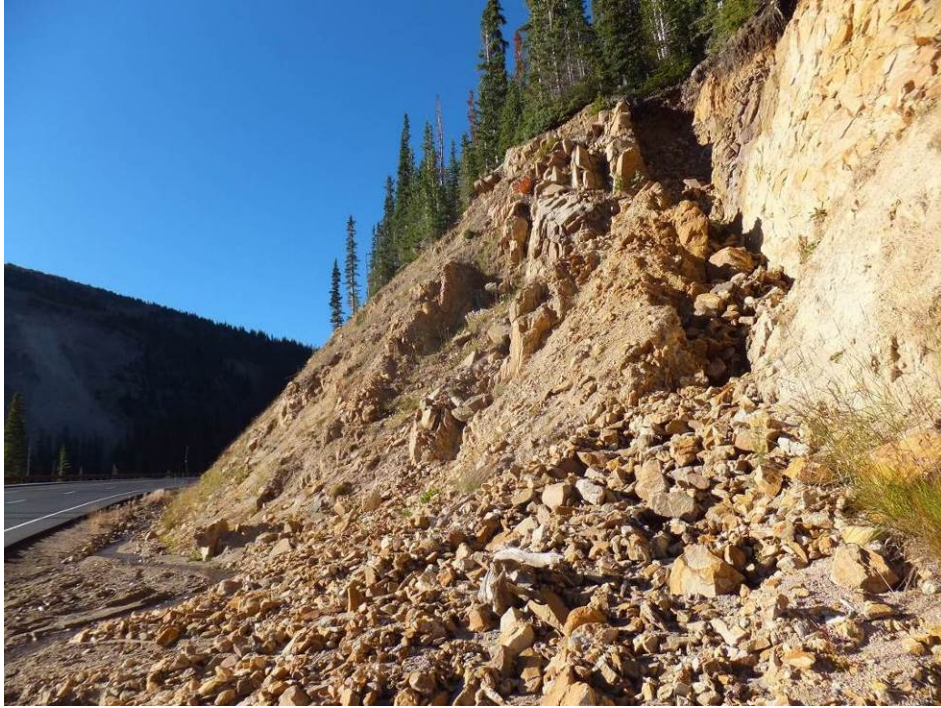
Figure 7-6. Milepost 241.48

At milepost 241.48, the igneous bedrock has collapsed as rockfall along a joint plane parallel to the roadway (**Figure 7-6**). This failure has formed a chute that is partially filled with rocks from the collapse. An alluvial fan of rockfall material has formed at the base of the chute. This chute has created a channel that could direct water and sediment into the naturally-formed stream parallel to the roadway, northward, and downslope. The chute is approximately 15 to 20 feet from the edge of asphalt. The wall of rock that remains standing between the road and the chute could also collapse. An additional investigation would be required to determine the impact of rockfall from this area onto the roadway. There may be enough area between the wall and the roadway to act as a rock catchment zone and buffer the roadway from most of the rockfall material, but that is unknown at this time. The site at milepost 241.48 is approximately 100 feet wide by 70 feet high.

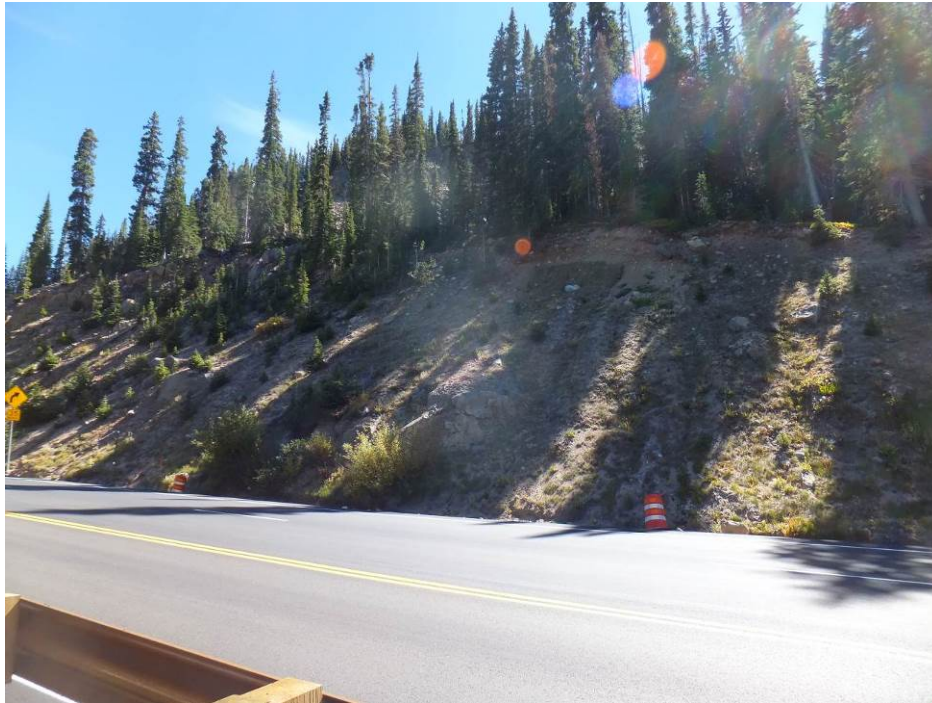
Figure 7-7. Milepost 241.3

observed at either location at the time of investigation. The site at milepost 241.3 is approximately 100 feet wide by 80 feet high; the site at milepost 241.28 is approximately 200 feet wide by 40 feet high.

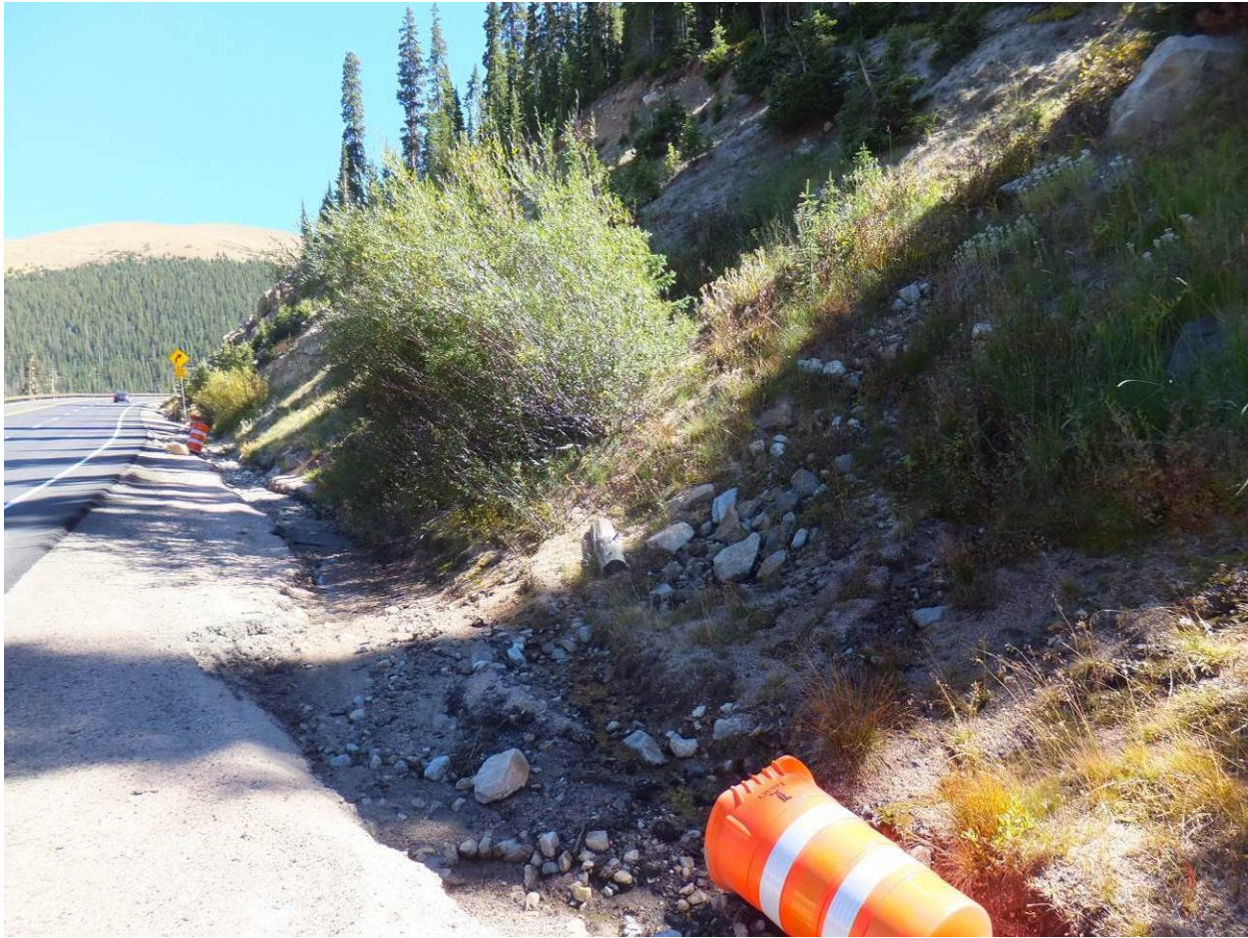
Figure 7-9. Naturally incised drainage ditch that serves as a catchment for small boulders between mileposts 241.28 and 241.3

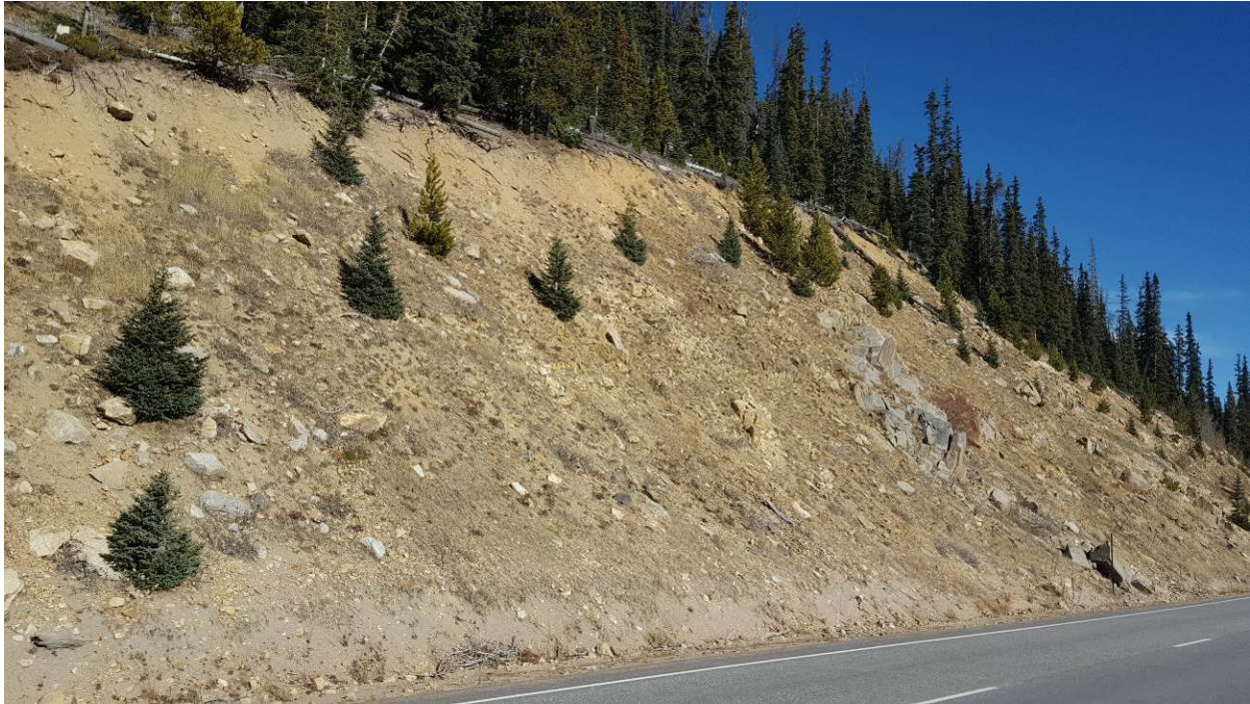
Figure 7-10. Milepost 240.6

The site at milepost 240.6 consists of several feet of glacial till overlying weak igneous bedrock (**Figure 7-10**). There is evidence of seasonal springs in the form of shallow slope failures and minor earthflow features that have removed the thin layer of topsoil and vegetation. No existing erosion control features were observed at the time of our investigation. This site is approximately 1000 feet wide by 90 feet high.

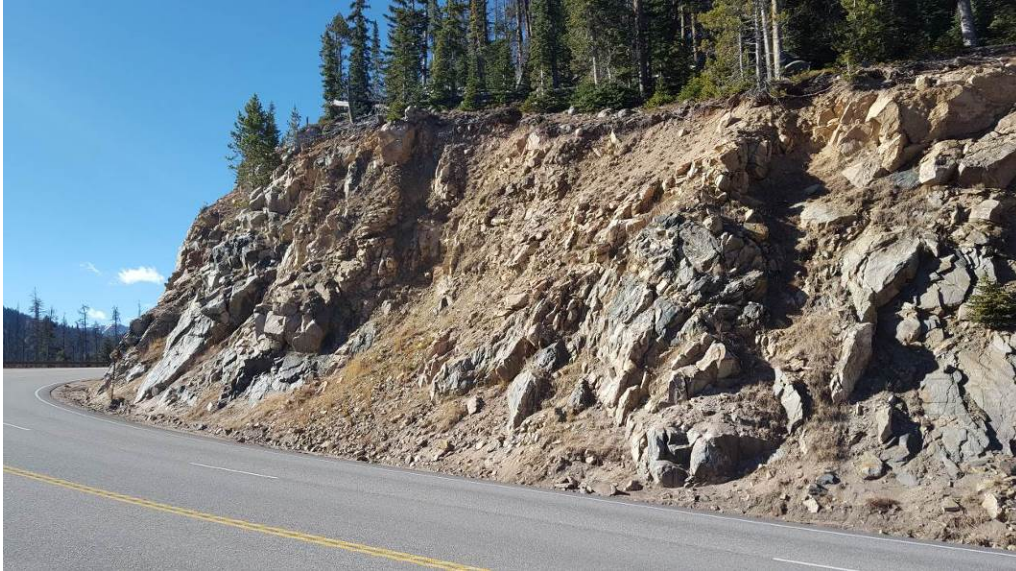
Poor quality igneous bedrock and a possible shear zone are present at milepost 239.7 (**Figure 7-11**). Joints in the bedrock are discontinuous and in unfavorable orientations. The possible shear zone is the prominent sediment source at this location; the rest of the identified site presents minimal to no sediment source but presents a rockfall hazard. This site is approximately 500 feet wide by 80 feet high; the shear zone is approximately 100 feet wide.

Figure 7-11. Milepost 239.7. Possible shear zone in center of photo

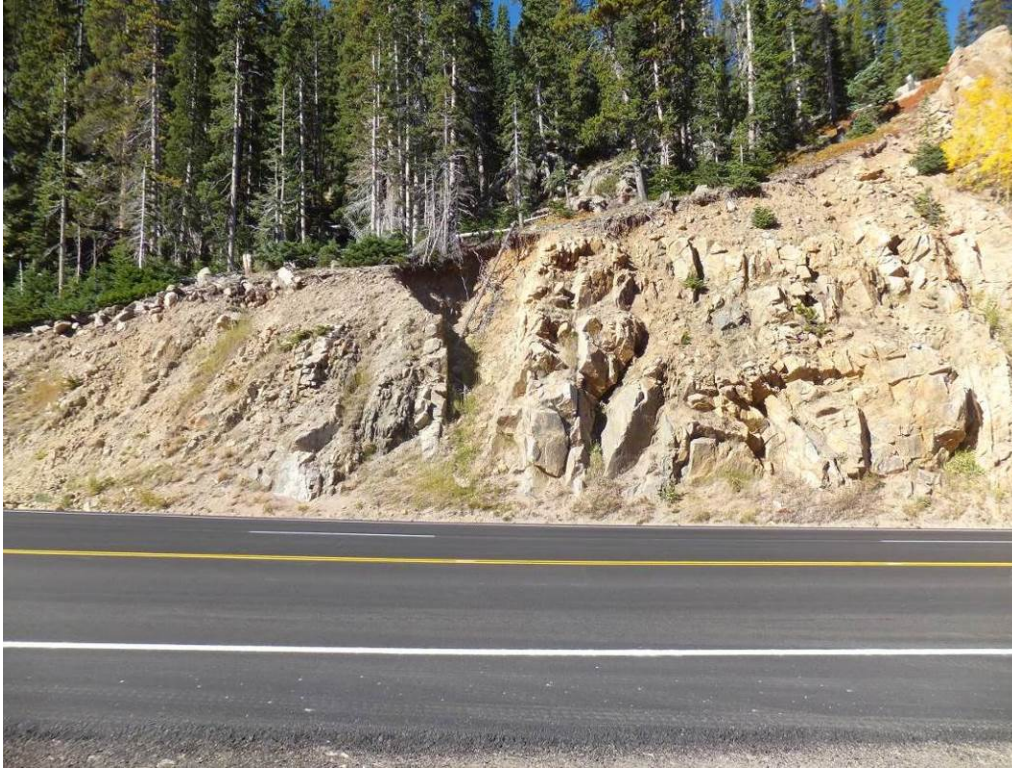
Figure 7-12. Milepost 239.56

The site at milepost 239.56 is a steep slope of northeast-facing weathered igneous bedrock that is jointed perpendicular to the roadway (**Figure 7-12**). The minimal topsoil with grassy vegetation tends to be near the bottom, and less steep, parts of the slopes. Conifer trees are growing on the upper portion of the slope immediately northwest of the slope failure. The slope failure is a collapse feature that failed as a rockfall along joint planes. The resulting chute is perpendicular to the roadway and appears to direct water and sediment towards the roadway. Although no large rocks were found during this investigation, rocks at the surface made mobile during precipitation events or by freeze/thaw could become mobile and travel along this chute. No large rocks were observed at the base of the chute during this investigation, and grasses were growing on fine granular material at the base of the chute. This indicates that the failure occurred some time ago as the rocks have been removed and vegetation has been re-established. At the top of the chute, the topsoil and root zone of the trees has been undercut and is in danger of collapsing into the chute and possibly into the roadway. No erosion control measures were observed. The dimensions of this site are approximately 50 feet by 50 feet.

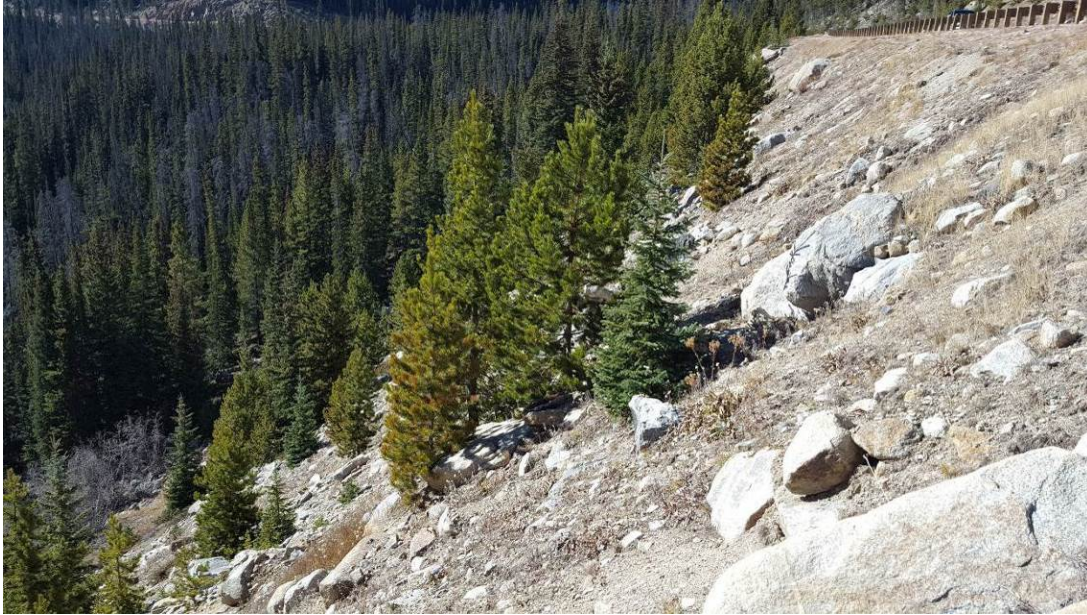
The fill side of the roadway at milepost 239.1 consists of alluvial and glacial till material (**Figure 7-13**). Sheetwash and surficial erosion has removed vegetation and prevented successful regrowth. The cutslope side of the roadway consists of glacial till and is performing well. Geocell matting is present along the brow. There is no curb at the base of the guardrail along this section of roadway. This site is approximately 800 feet wide and as much as high as 350 feet.

Figure 7-13. Fill side of roadway at milepost 239.1 affected by slope wash and surficial erosion

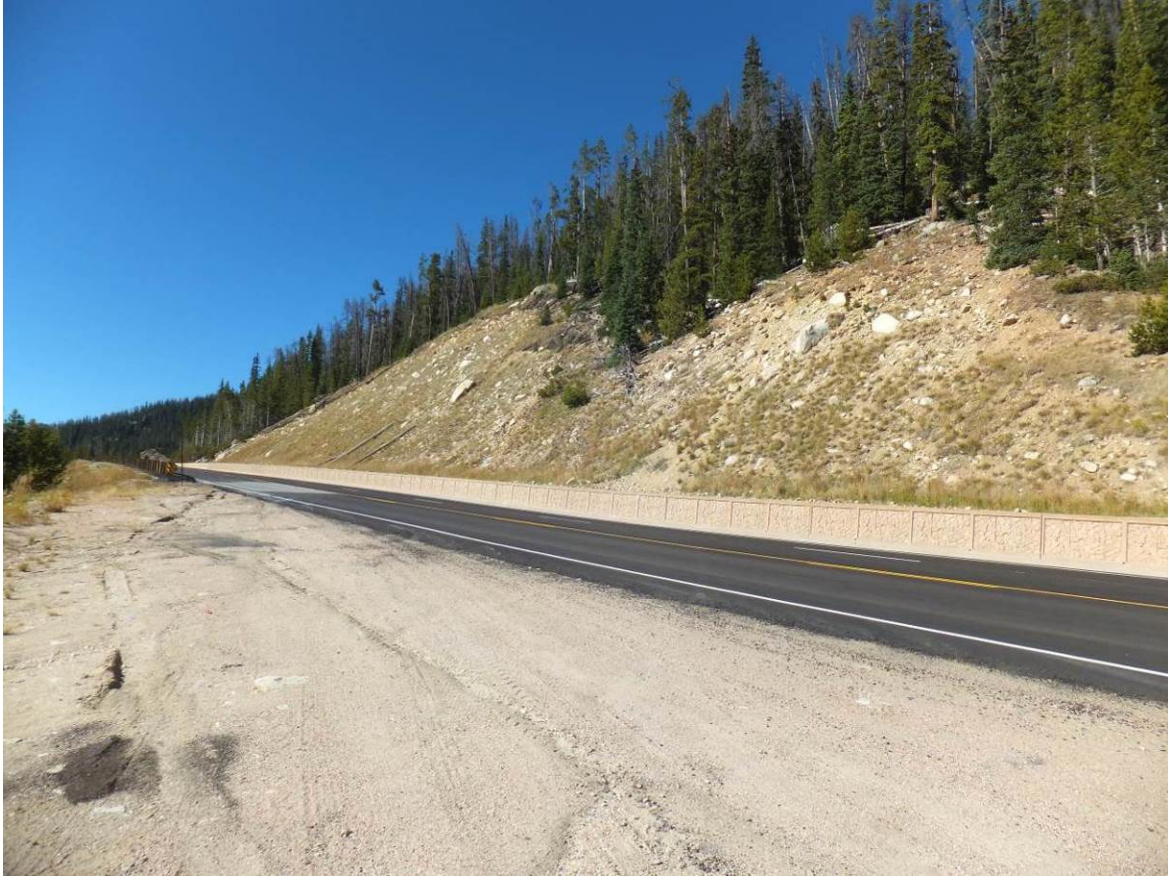
Figure 7-14. Milepost 238.7

The oversteepened slope at milepost 238.7 is comprised of glacial till deposits that include exposed boulders approximately 6 feet in diameter (**Figure 7-14**). The slope has a minimal layer of topsoil supporting tufts of grass and some wildflowers. A scarp at the top of the eroded section suggests the failure originated as an earthflow. Further erosion continues due to slope wash and seasonal spring blowouts. No vegetation was growing on this eroded section at the time of investigation. Much of the material removed from the slope has accumulated at the base of the slope and on the barrier wall (**Figure 7-15**). Some gravel and small boulders have fallen onto the concrete ditch, and at least one small boulder had reached the asphalt of the roadway at the time of investigation (**Figure 7-16**). No sediment control measures, aside from the wall and ditch, were observed at the time of investigation. The brows are partially covered with cellular and erosion control blankets. This site is approximately 800 feet wide by 100 feet high.

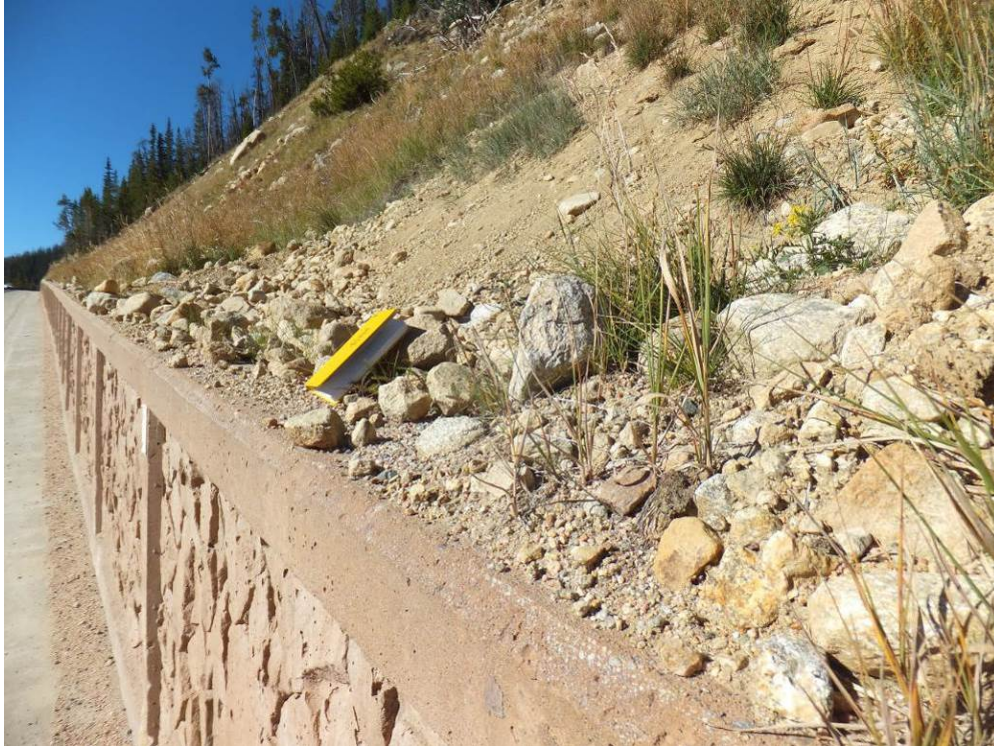
Figure 7-15. Accumulation of slopewash material at milepost 238.7

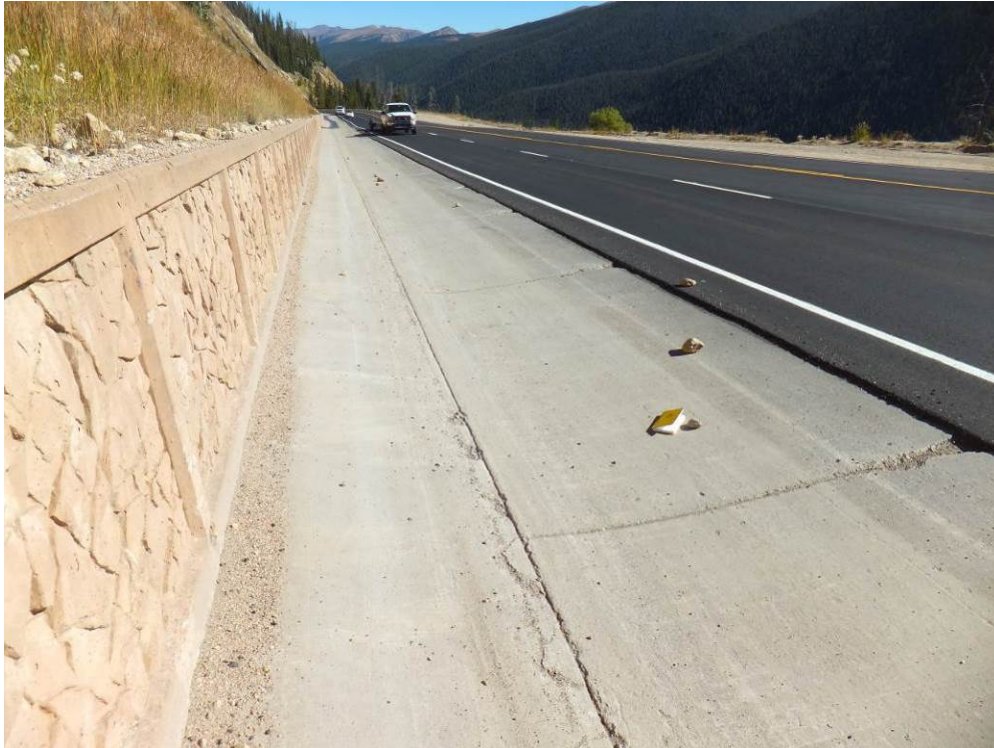
Figure 7-16. Small boulders that have fallen onto the concrete ditch and asphalt roadway at milepost 238.7

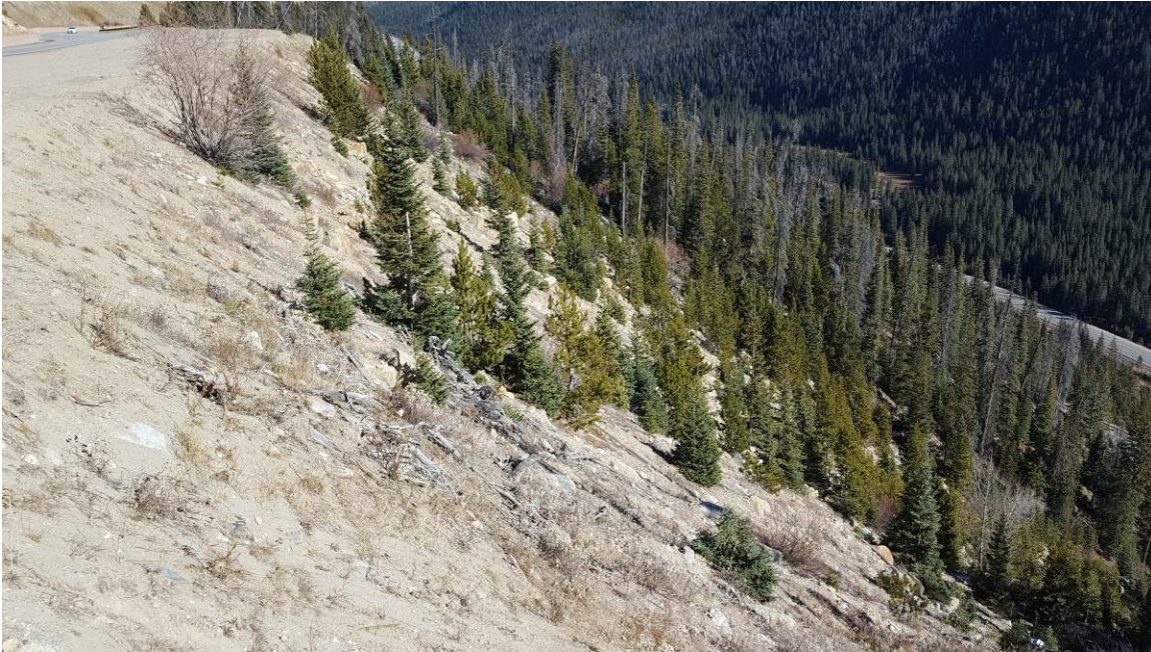
Figure 7-17. Milepost 238.65

At 238.65, the fill side of the roadway consisting of alluvial and glacial till material is affected by sheetwash and surficial erosion (**Figure 7-17**). Much of the vegetation has been removed or covered with soil resulting in extensive rill erosion. There is no curb beneath the guardrail along this section of the road. This site is approximately 1000 feet wide and as high as 350 feet.

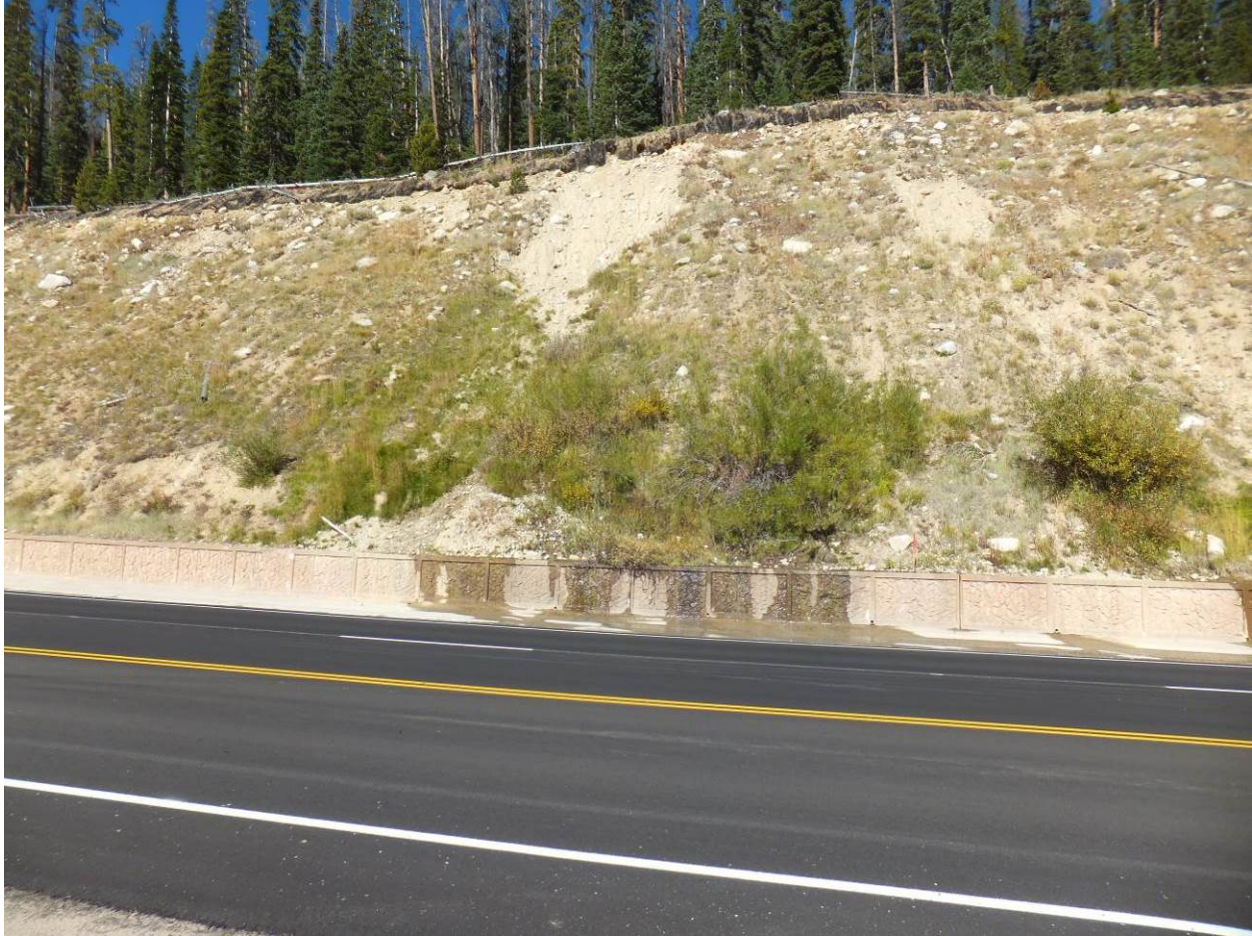
Figure 7-18. Milepost 238.4

The oversteepened slope at milepost 238.4 is comprised of glacial till deposits. There are several apparent failures on the slope due to slopewash and seasonal spring blowouts. Rocks and sediment have accumulated near the bottom of the slope and on the barrier wall beneath the larger eroded section. Water has ponded at the base of the slope immediately behind the wall and was actively flowing over the wall at the time of investigation. Lush, yellow-green vegetation, including willows, growing in and near the ponded water indicate that springs are perennially active. Water has been flowing over the wall long enough for algae to grow on the wall. The slopewash failure is significantly higher than the springs and therefore should not be affected by the lower perennial spring water. The largest eroded area on the slope appeared very similar at the time of site visit to the Google Street View images dated October 2012. The smaller of the two most prominent eroded areas as seen in **Figure 7-18** is much less noticeable in the Google Street View images and appears to have grown significantly between the Google image date of October 2012 and the time of our investigation. This site is approximately 1200 feet wide and 100 feet high.

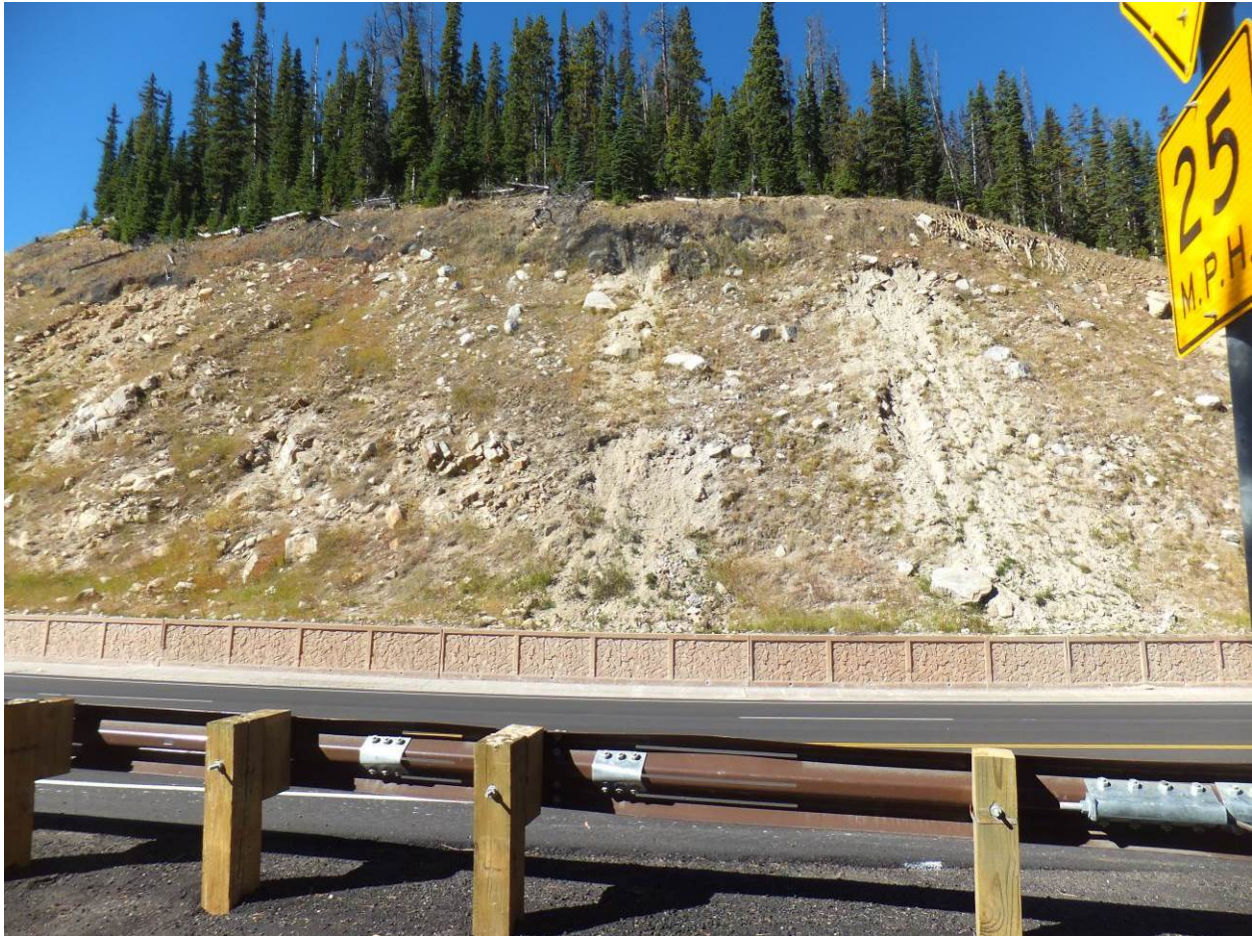
At milepost 238.2 is an east-northeast-facing oversteepened slope of glacial till deposits and some poorly exposed, highly weathered outcrops of igneous bedrock on the lower portion of the slope (**Figure 7-19**). The thin layer of topsoil appears to support a variety of grasses. Large boulders, greater than 3 feet diameter, were exposed on the slope at the time of our site visit. These slopes had experienced seasonal seeps and spring blowouts and significant slopewash. One large boulder had apparently recently become loosened and slid down to rest near the barrier wall. Pieces of concrete have been removed from the top of the barrier wall, apparently due to damage from falling boulders. The brow of the slopes have been covered with erosion control and cellular blankets. The slopes are partially covered with snow in the Google Street View images dated October 2012, but the blowout and erosion in the center of the site appears to be smaller than at the time of site visit and appears as a scarp with minimal erosion below. The blowout and erosion on the western portion of the slope is not apparent in the Street View images but boulders and tufts of grass dot the slope indicating that most or all of the slopewash occurred between October 2012 and the time of investigation. This site is approximately 450 feet wide and 100 feet high.

Figure 7-19. Spring blowouts (shallow localized slope failures) and slopewash at milepost 238.2

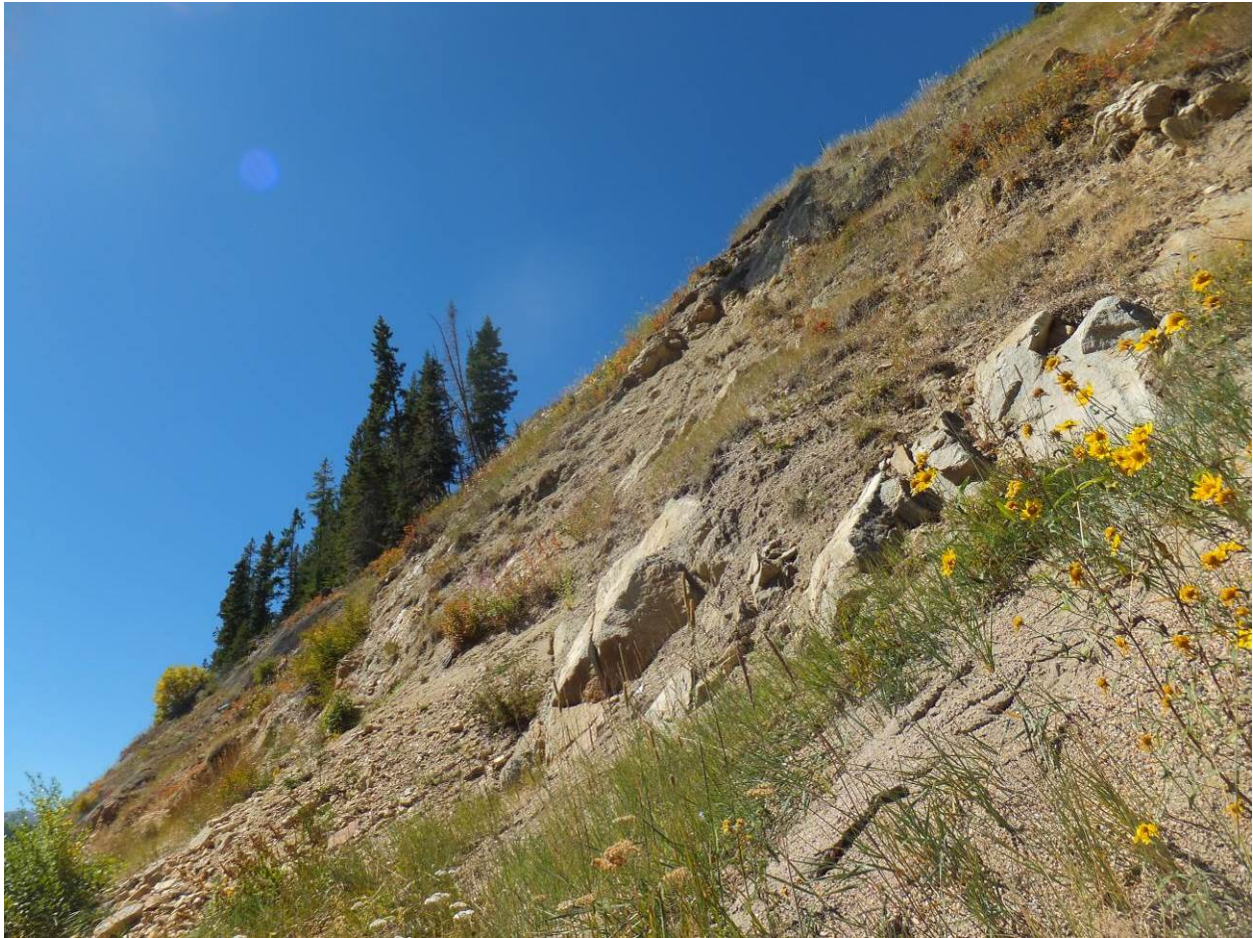
north and south currently unmeshed portions of this slope are referred to as sites A and B, respectively. Site 237.9 A is approximately 50 feet by 50 feet and site 237.9 B is approximately 300 feet wide by 60 feet high.

Figure 7-20. The upper slope at milepost 237.9, as viewed from the lower switchback

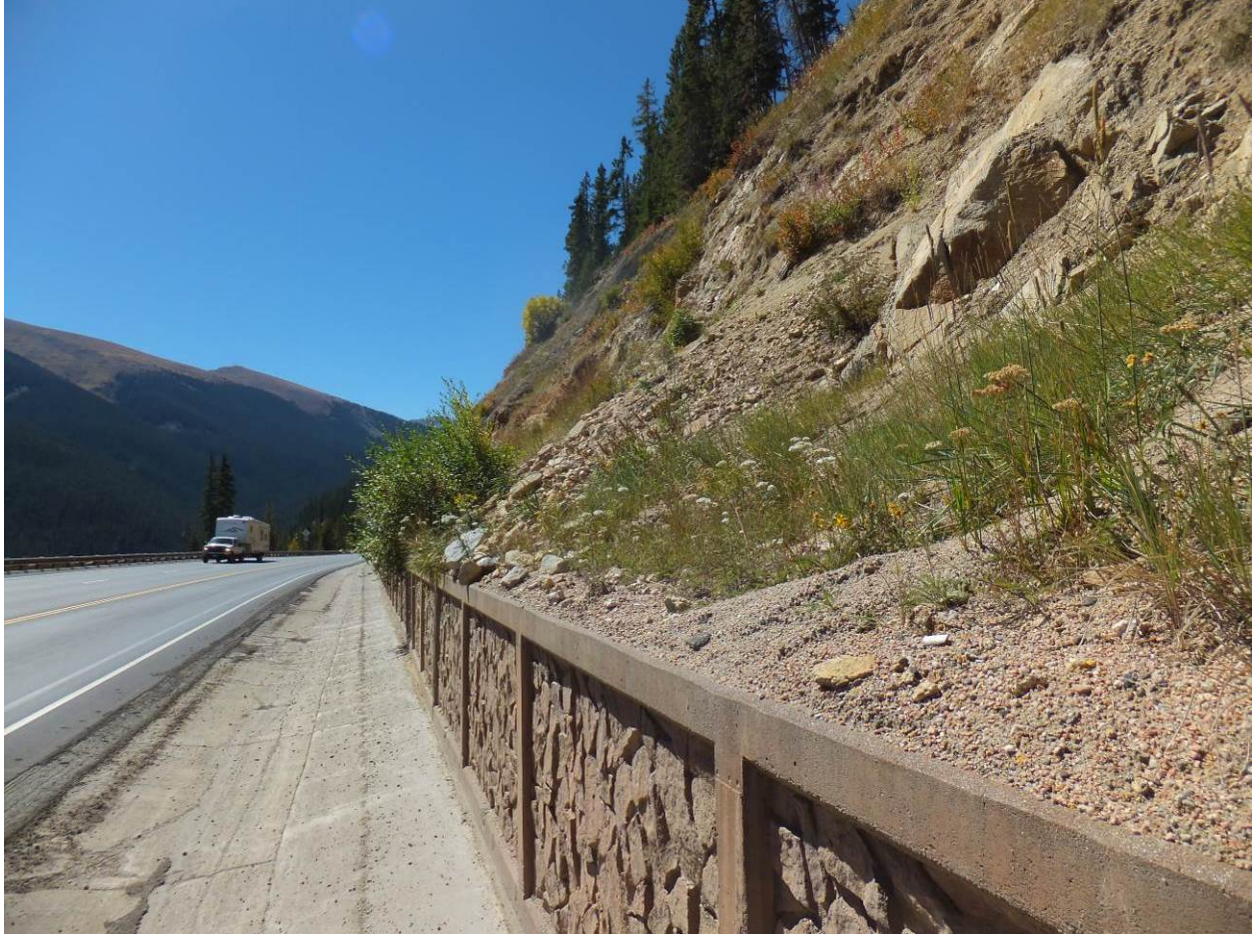
Figure 7-21. Accumulation of sediment on the knee wall and the lower portion of the slope at milepost 237.9

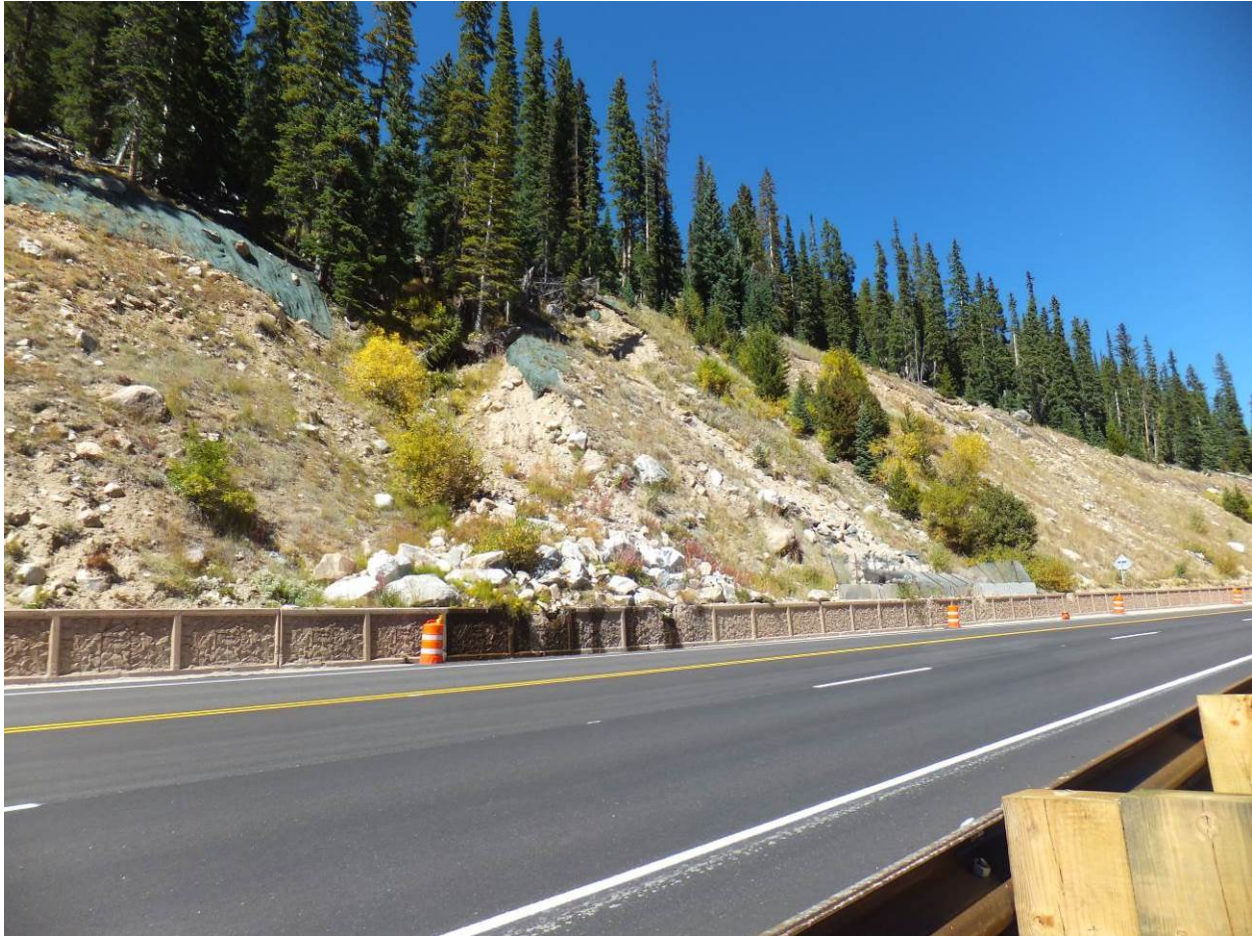
the slope appears very similar in the Google Street View images dated October 2012 to the condition at the time of our investigation. The Street View images show two tree trunks on the northern failure that appear to have been removed by the time of our first site visit. A young conifer tree growing in the middle of the northern failure at the time of our site visit is not apparent in the Street View images, indicating that the slope has been stable enough to support some vegetation regrowth within the last several years. Site 237.6 A is approximately 200 feet wide by 50 feet high; site 237.6 B is approximately 35 feet wide by 50 feet high; site 237.6 C is approximately 25 feet wide by 80 feet high.

Figure 7-22. Milepost 237.6 showing (A) the glacial till slope (left), (B) active drainage channel with collection of boulders on knee wall (center), and (C) former drainage filled with till and alluvium (right, above damaged Type 4 barrier and fencing)
