**BERTHOUD PASS WEST
SEDIMENT CONTROL ACTION PLAN
US 40 Milepost 232.8 to 244.3**

Colorado Department of Transportation

**Clear Creek Consultants
Felsburg Holt & Ullevig
Yeh & Associates**

May 2017

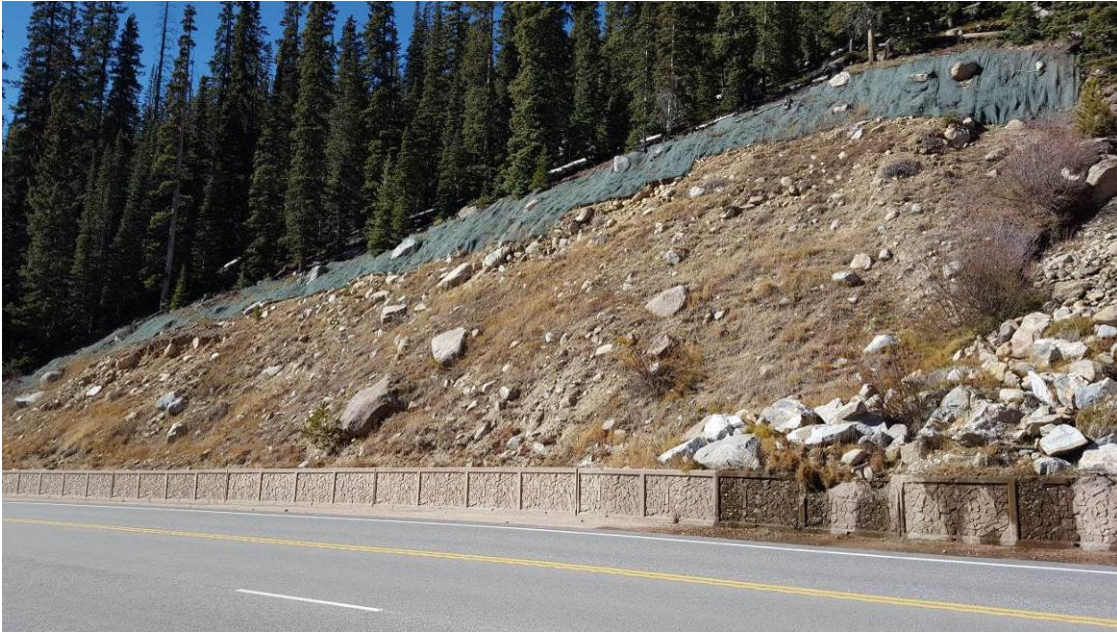
Figure 7-23. Milepost 237.6 A, slope of glacial till with erosion blanket at brow

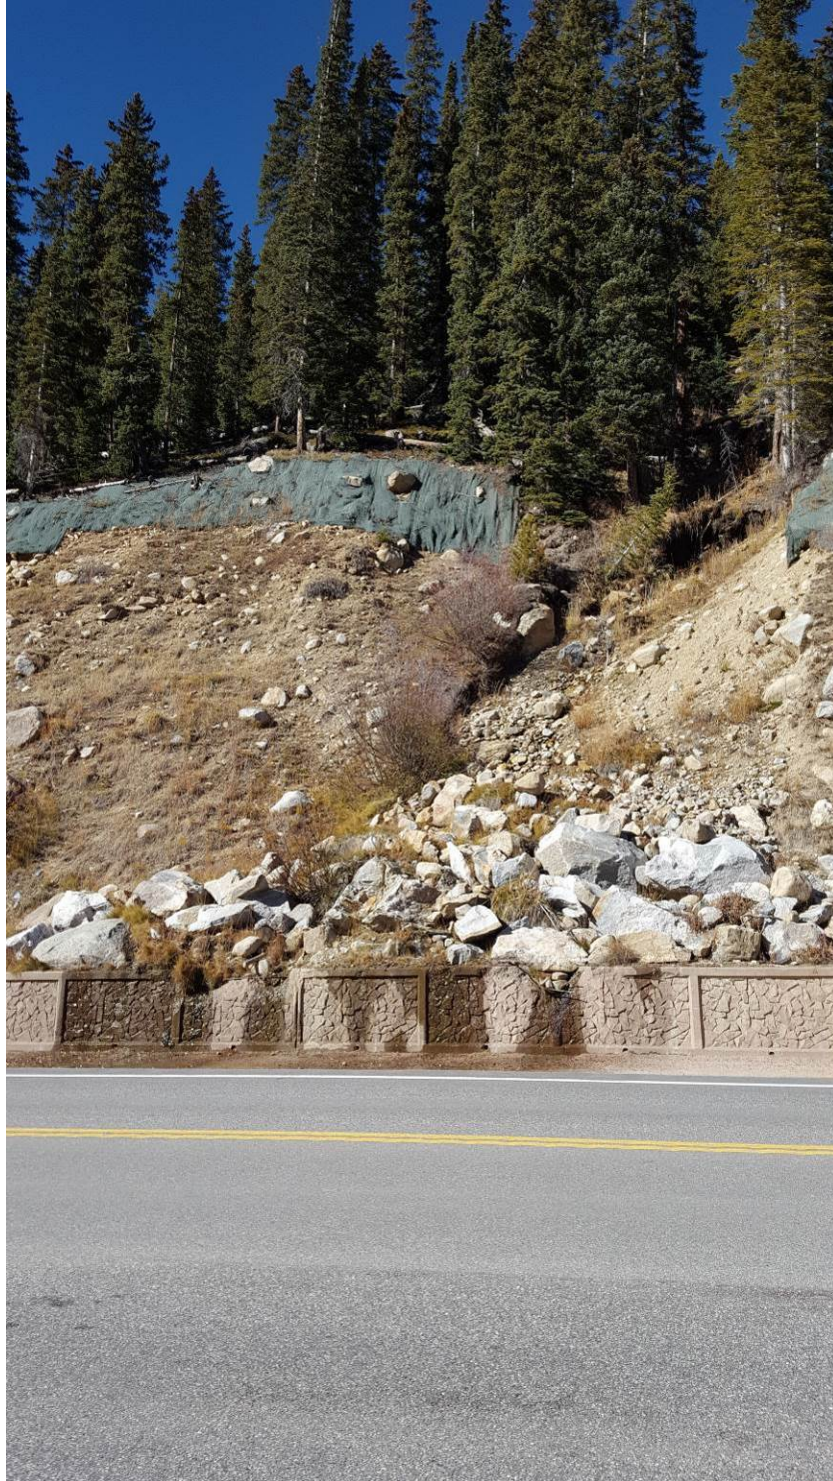
Figure 7-24. Milepost 237.6 B, perennial stream drainage with collection of boulders above knee wall. Some boulders were placed for erosion control while others rolled from the slope above

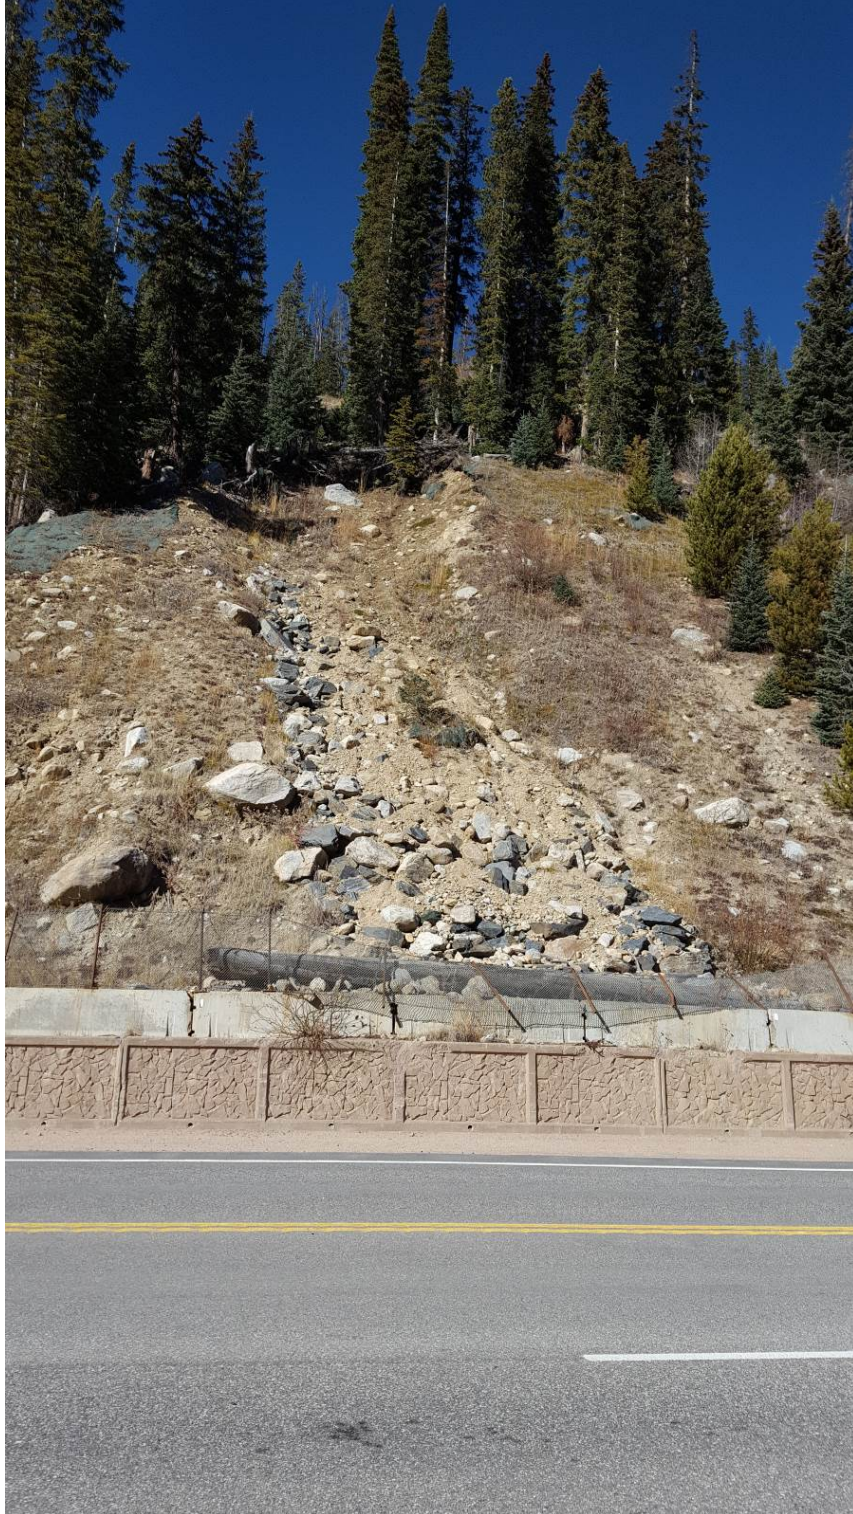
Figure 7-25. Milepost 237.6 C, drainage channel which was partially stabilized with boulders and fill during the mid-90's slope stabilization projects. Type 4 barrier and fencing placed on top of knee wall for erosion and rockfall control has been heavily damaged

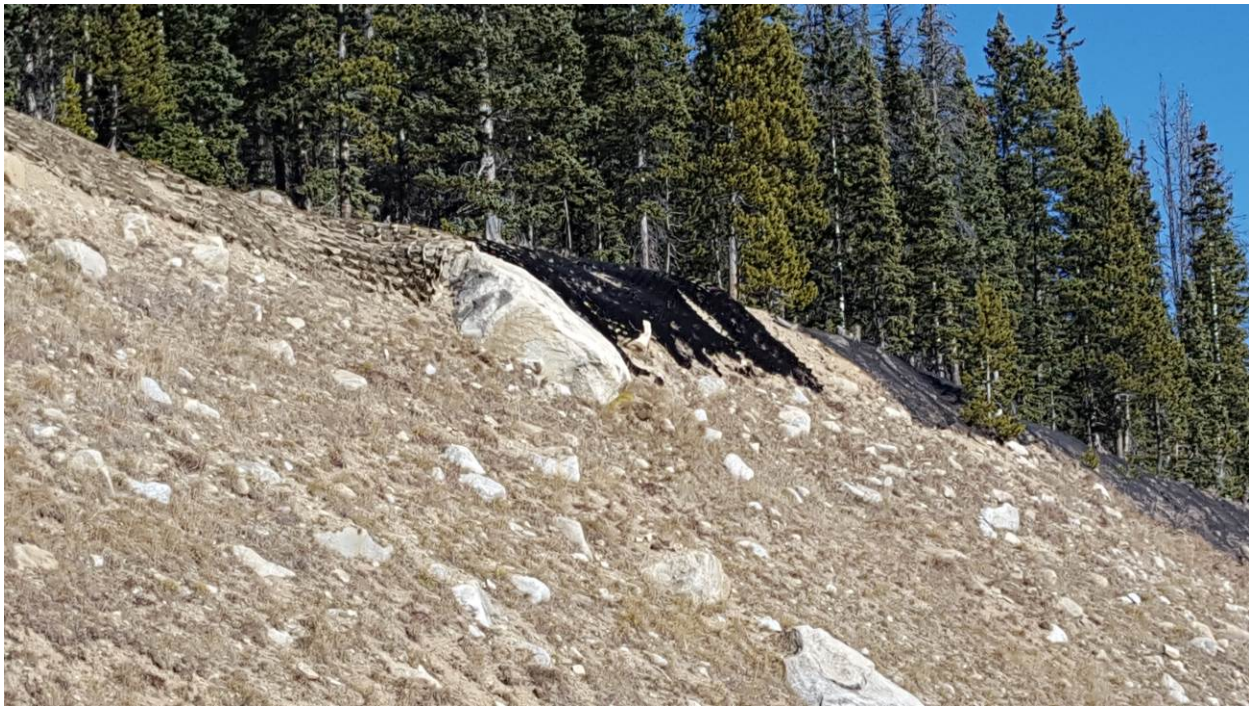
Figure 7-36. Poorly-performing Geocell mats (left and center) and better-performing Enkamat (right)
