| FED. ROAD DIST. NO. | STATE | FED. AID PROJ. NO. | SHEET NO. | TOTAL SHEETS |
|---|---|---|---|---|
| 1 | COLO. | 254-C | 1 | 1 |

1. TITLE
2. SECTIONS & SUMMARIES
- 3-4. SUBSTRUCTURE DETAILS OF BRIDGE
- 5-7. SUPERSTRUCTURE
8. SYPHON DETAILS
9. STANDARD WIRE CABLE GUARD FENCE
10. CULVERT HEADWALLS
11. PLAN & PROFILE
- 12-19. CROSS SECTIONS
- 9A. STD CONCRETE PROJECT MARKER

# COLORADO STATE HIGHWAY DEPARTMENT PLAN AND PROFILE OF PROPOSED FEDERAL AID PROJECT NO. 254 C STATE HIGHWAY NO. 2 GRAND COUNTY

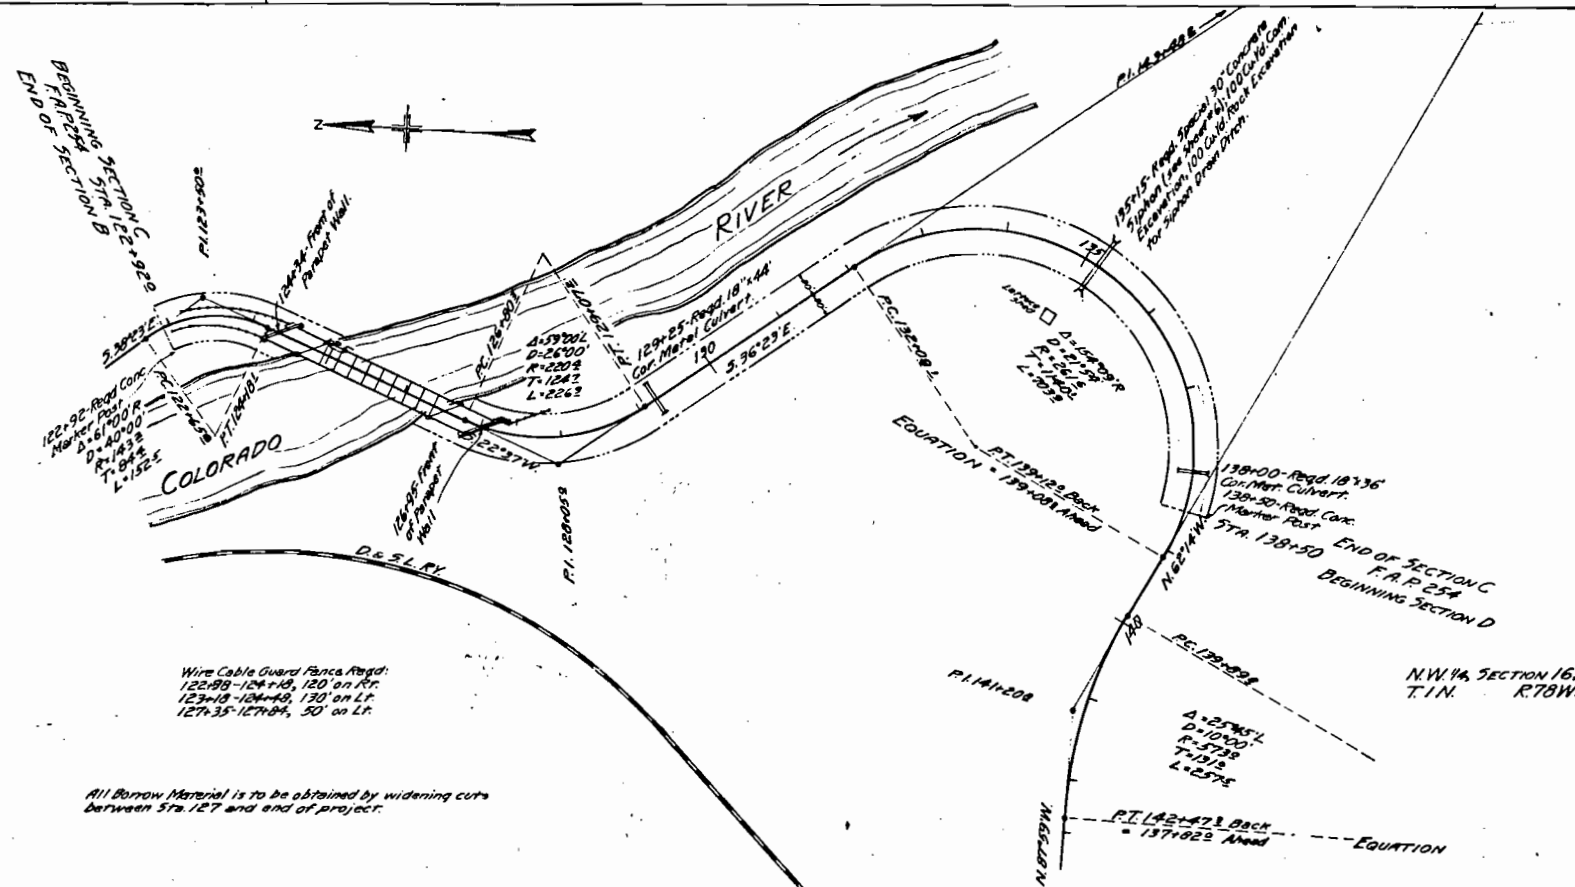
# BRIDGE NOTES

| <b>PROPOSED STRUCTURE</b> | Position referred to Present Structure New Alignment<br>Span 81'-178'-83" |
| <b>TYPE OF SUPERSTRUCTURE</b> | Truss |
| <b>TYPE OF SUBSTRUCTURE</b> | Concrete |
| <b>STRENGTH DATA</b> | Drainage Area in Sq. Mi.<br>Velocity during High Water<br>Elevation of<br>Maximum High Water Reported 1938<br>Date<br>Normal High Water<br>Normal Stage 7545.2<br>Extreme Low Water<br>Station Bed 7538.6<br>Drift carried during Flood Heavy Logs<br>Probable Depth of Scour during Floods<br>Very Little |
